ENVIRONMENTAL PRIORITIES INITIATIVE PRELIMINARY ASSESSMENT OF INTERNATIONAL PAPER COMPANY PREPARED UNDER

TDD NO. F3-9004-01 EPA NO. PA-2628 CONTRACT NO. 68-01-7346

JULY 27, 1990

NUS CORPORATION SUPERFUND DIVISION

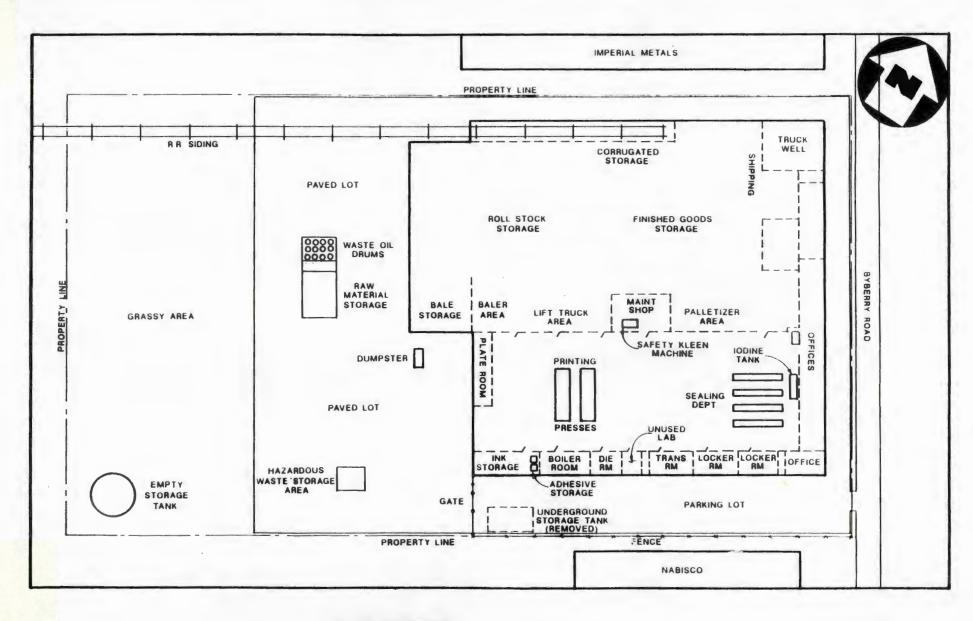
SITE SKETCH
INTERNATIONAL PAPER, PHILADELPHIA, PA
(NO SCALE)

The Liquid Packaging Division encompasses approximately 16.6 acres (see figure 2.2, page 2-3). Two structures are located on site, a manufacturing building and a hazardous waste storage area. Access to the property is off Byberry Road.^{2,3}

The manufacturing building is bordered in the front (to the east) by a parking lot for visitors and office employees. The production employee parking lot borders the manufacturing building to the south. A macadam area used for loading and unloading, the hazardous waste storage area, and the waste oil storage area border the manufacturing building to the west (rear). Railroad tracks enter the property from the west and proceed into the manufacturing building. Imperial Metals borders the site to the north, and Nabisca borders the site to the south. The dimensions of the manufacturing building are 375 by 450 feet. The long axis of the building lies in an east to west orientation.^{2,3}

The hazardous waste storage area is located approximately 125 feet southwest of the manufacturing building and is surrounded by a locked 6-feet-high chain-link fence with a rolling gate. This storage area sits on a concrete slab and is surrounded by an 8-inch-high containment curb that is 13 feet, 2 inches by 13 feet, 3 inches.^{2,3}

The interior of the manufacturing structure is divided into two areas by a concrete-block wall trending east to west. The northern side of manufacturing area houses the roll-stock storage area, the finished-goods storage area, the railroad-unloading area, the shipping area, the palletizer area, and the maintenance shop. The one area of concern in this portion of the building is the Safety Kleen maintenance shop degreaser.^{2,3}

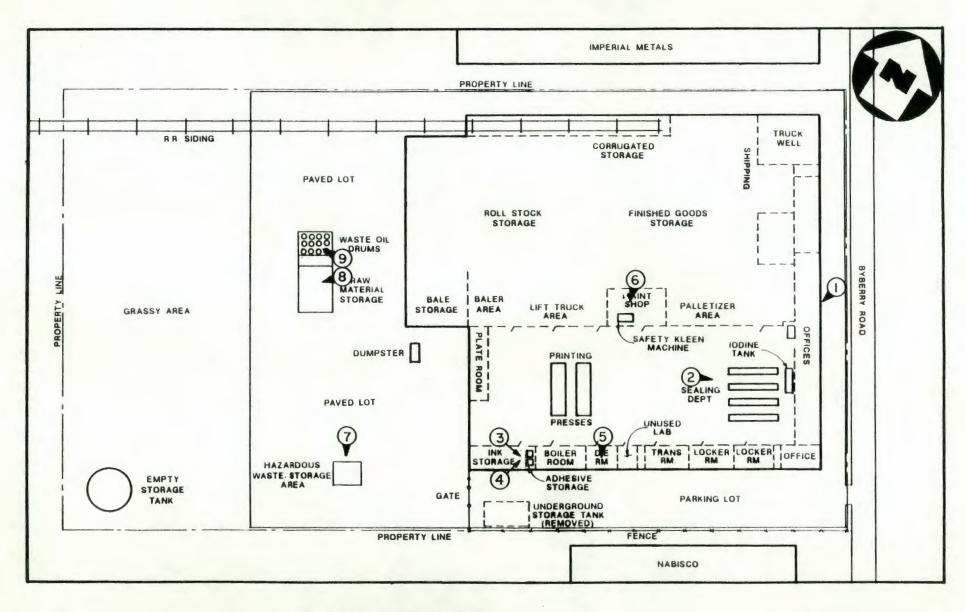
PHOTO LOCATION MAP

On Thursday, May 3, 1990, NUS FIT 3 members Kim Walters and Paul Persing visited the International Corporation, Liquid Packaging Division, in Philadelphia, Pennsylvania. International representatives James Chartrand, Mario Domingues, and Dennis Hughes granted site access and accompanied the team during the site visit. Weather conditions were partly cloudy, and the temperature was 65°F. Photographs were taken on the site (see figure 5.1, page 5-4, and the photograph log, section 5.4).
